Experimental Evaluation of Face Gears for Aerospace Drive System Applications

Robert F. Handschuh and David G. Lewicki Vehicle Propulsion Directorate U.S. Army Research Laboratory Lewis Research Center Cleveland, Ohio

Prepared for the Seventh International Power Transmission and Gearing Conference sponsored by the American Society of Mechanical Engineers San Diego, California, October 6–9, 1996

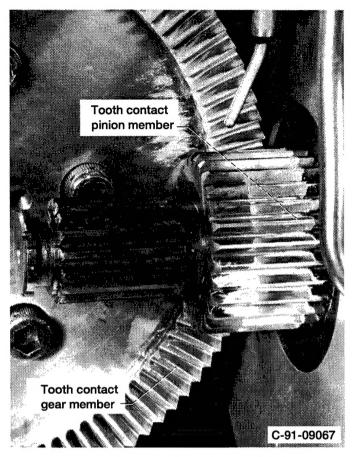
As mentioned earlier the axial positioning of the pinion with respect to the gear is not critical as it is in a spiral bevel gear mesh. The pinion was positioned to facilitate proper connection to the rest of the test facility. The gear member was adjusted axially via shims to provide the backlash of 0.05 to 0.10 mm (0.002 to 0.004 in.). The contact pattern at light load was also checked in a manner as used for spiral bevel gears. A photograph of the contact pattern is shown in Fig. 5.

Figure 5.—Photograph showing contact pattern using red lead.

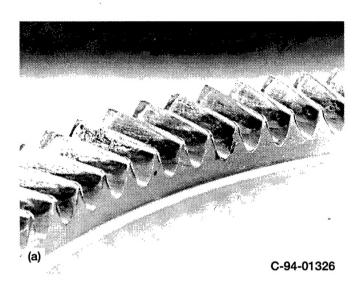
Photographs of the different test hardware failure modes and posttest condition will now be presented. In Fig. 6 gear set "E", a baseline gear set, is shown in the post-test condition. Pitting damage is shown but the two teeth that failed were bending initiated.

Figure 6.—Bending fractures of face gear teeth, test speciman set "E" (baseline). (a) Failed teeth set in place. (b) Failed teeth removed

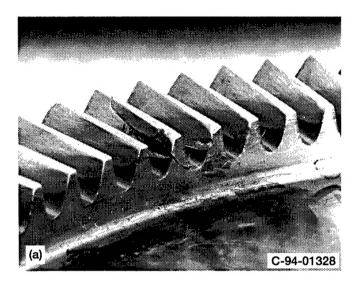
Figure 7 shows a typical pitting initiated tooth fracture (gear set "G"). A large pit developed on one of the teeth to a size large enough to cause the fracture of the tooth as shown in Fig. 7(b). This type of failure was the predominant one found in the study conducted herein.

Figure 7.— Pitting initiated failure that led to tooth fracture from face gear set "G". (a) Failed tooth in place. (b) Failed tooth removed.

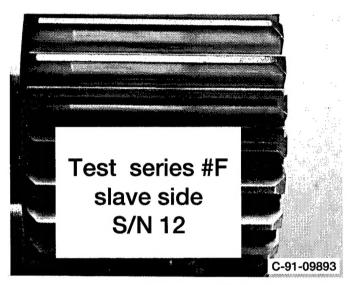
In Fig. 8 the pinion from gear set "A" after testing is shown. The contact location on the pinion is evident from the slight polishing of the surface, however no damage to the surface occurred. This type of pinion condition was typical for all the tests conducted.

Figure 8.—Pinion from face gear set "A" after 30 million cycles at 100% load and 30 million cycles at 200 % load.

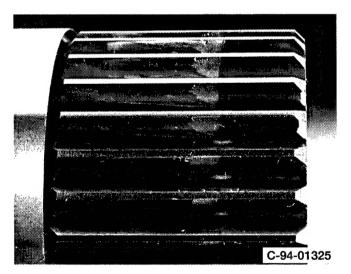
Figure 9 shows the pinion from gear set "H" after the completion of all tests. As mentioned earlier in this section of the report, this particular gear set accumulated the greatest amount of run time (168 million cycles at 100 percent load, 30 million cycles at 200 percent load). The contacting region between the pinion and gear are clearly indicated. Micropitting has occurred at various regions over the surface with a large concentration occurring at the region that meshes at the inner diameter of the gear member.

Figure 9.—Pinion from face gear set "H" (nitrided) after 168 million cycles at 100% load and 30 million cycles at 200% load.

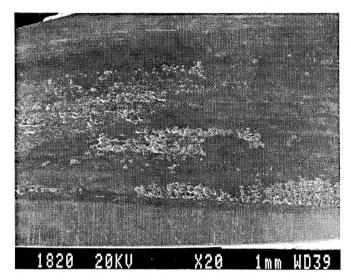
Figures 10 and 11 are photographs taken of a tooth from the failed gear set "J" in a scanning electron microscope. Both figures were taken of the tooth that failed in bending. Figure 10 shows a close-up of the contacting region micropitting. This type of surface damage was found in various stages on all gear members tested in this study. Figure 11 is a photograph of the fracture surface.

Figure 10.—Pitting damage typically found during testing. (set "J").

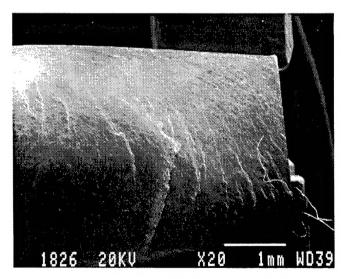
Figure 11.—Photograph of bending failed tooth fracture surface. (set "J").
